Tropical Cyclone Debby

Open File Report

Storm History and Impacts Report

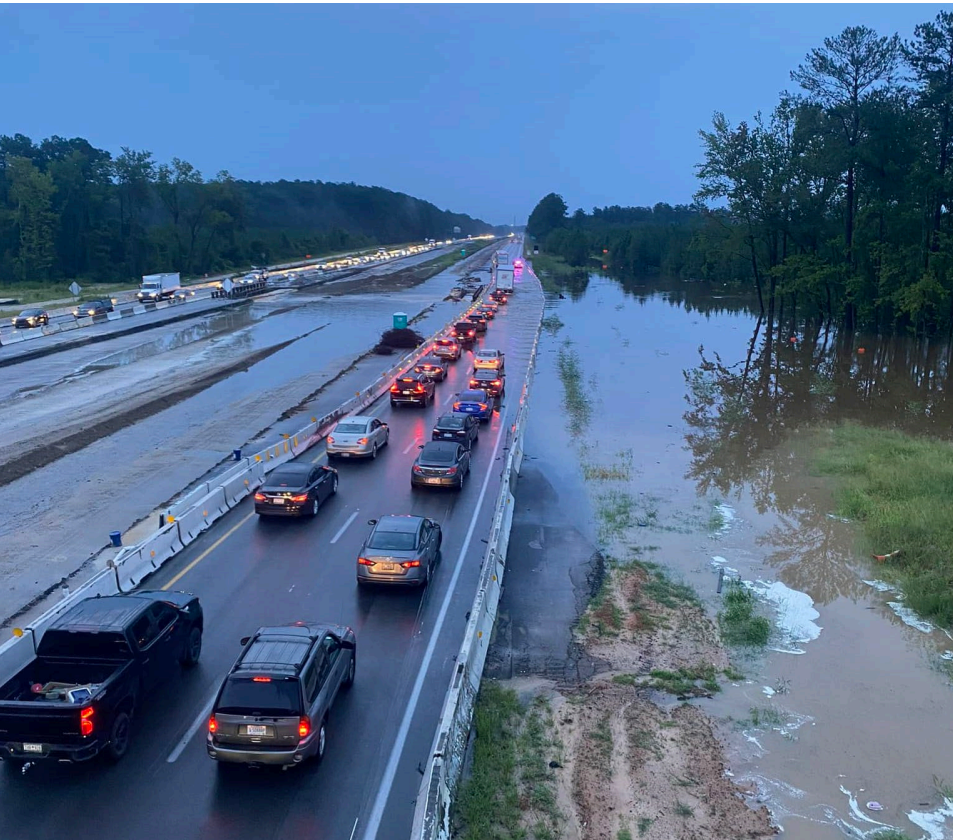
Motorists became stuck on I-26 near Ridgeville on August 8 because of flash flooding.

Heavy rain in the Lowcountry led to widespread flash flooding and numerous road closures. One example was along I-26 at mile marker 189 near Ridgeville. The interstate had to be closed in this area at around 8 a.m. on August 8 as it became impassible due to flooding. The flood waters damaged the eastbound lanes, resulted in them remaining closed for a few days while they were repaired. The detour around the closure resulted in delays of up to an hour some commuters relying on the interstate. One eastbound lane and the westbound lanes reopened on August 9 after waters receded and the other lane reopened on the morning of August 10 after the repairs were completed.

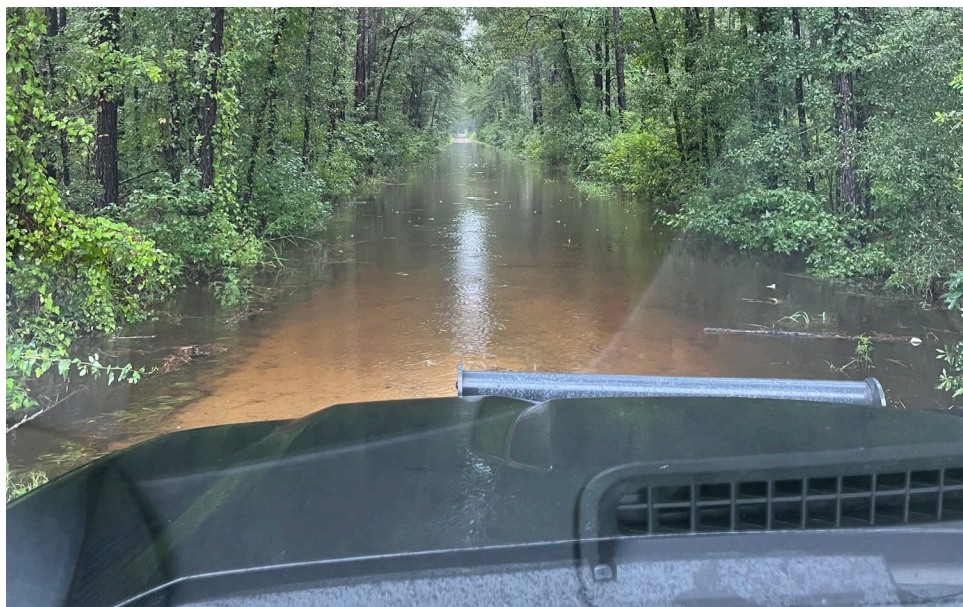
Flooding slowed access to a radio repeater in Colleton County.

Flash flooding initially prevented technicians from reaching a radio repeater facility in Jasper County on August 6. With help from SCDNR law enforcement vehicles, the technician was able to reach and perform maintenance on the equipment.

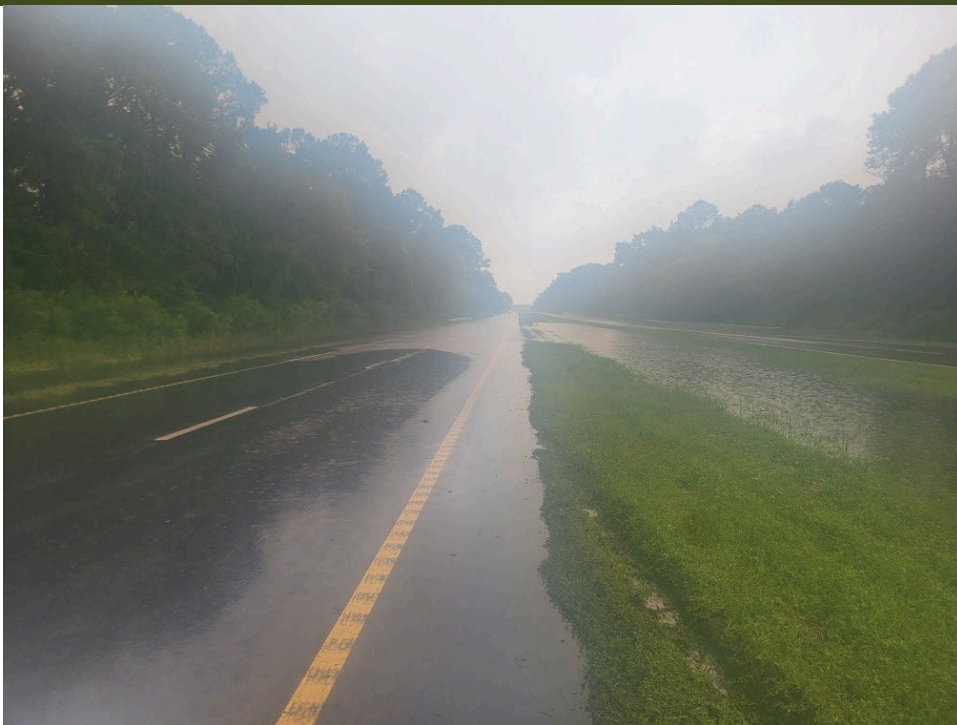
Flash flooding on August 6 along U. S. Highway 17 near Seewee Road in Awendaw led to the closure of the road for a time and detours around the flooding.

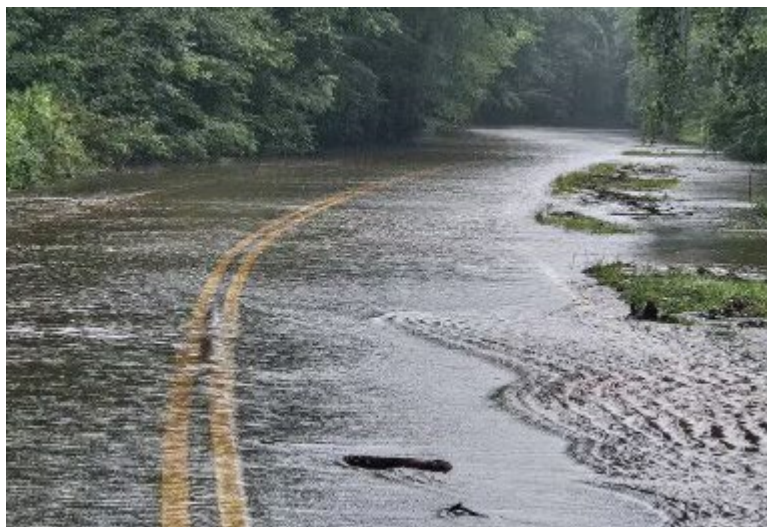
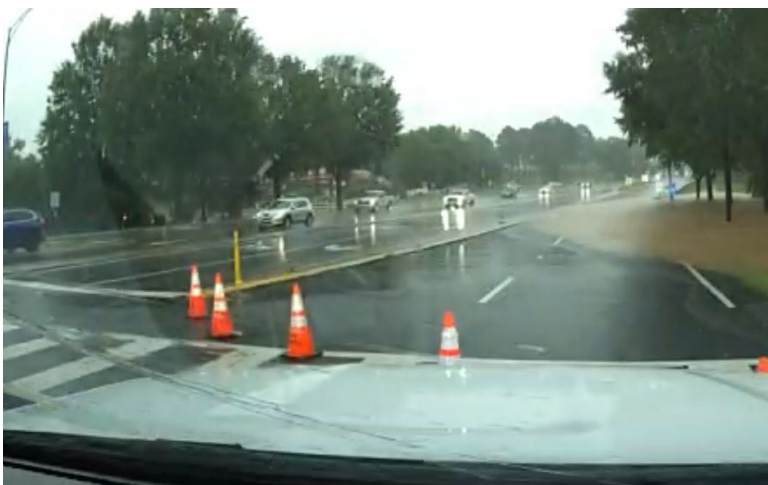
Flash flooding also occurred on Guerins Bridge Road in Awendaw, leaving it impassible on August 6.

Flash flooding closed the eastbound lanes of Dave Lyle Boulevard near Chamberside Drive on the morning of August 8.

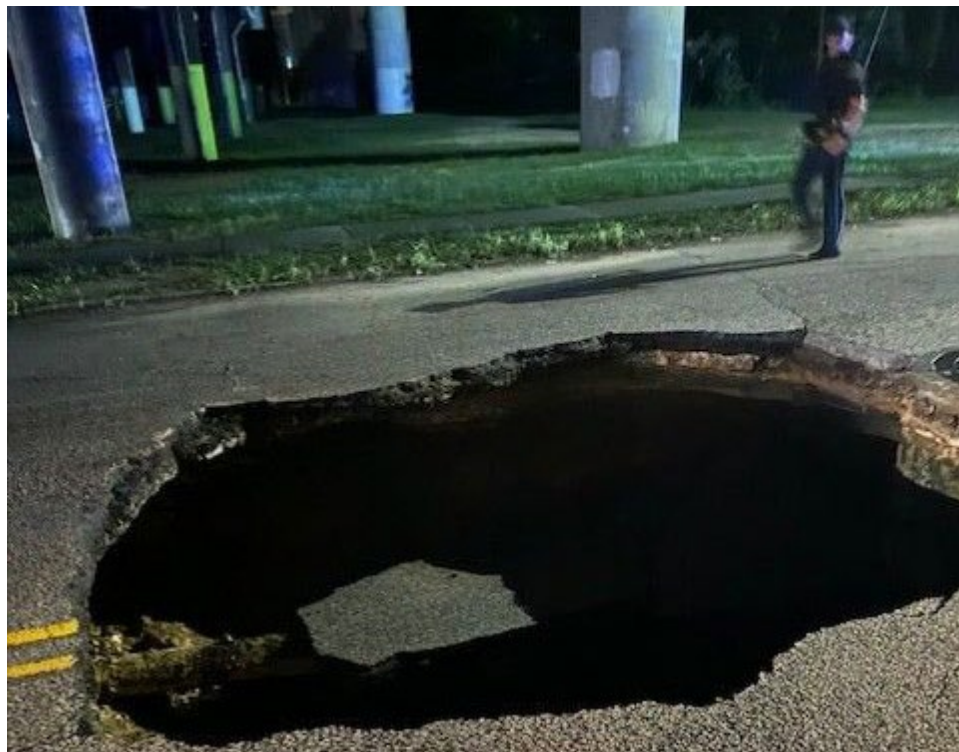
This sinkhole to form on Romney Street in Charleston on August 7. The cause was a burst pipe; it's unclear if rainfall from Debby caused the pipe to burst.

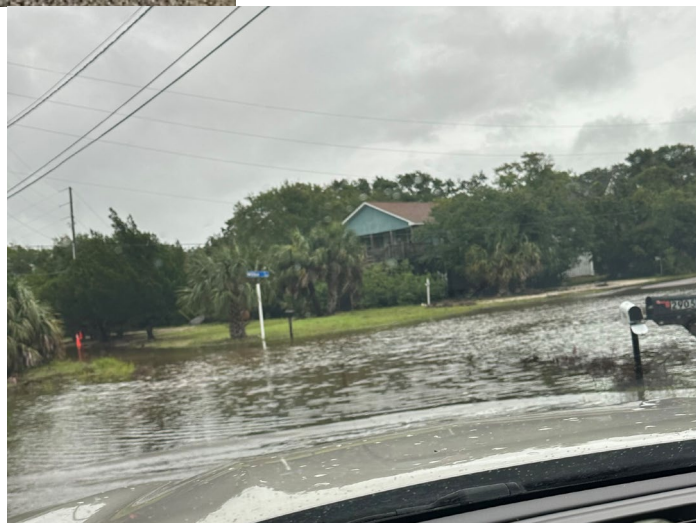
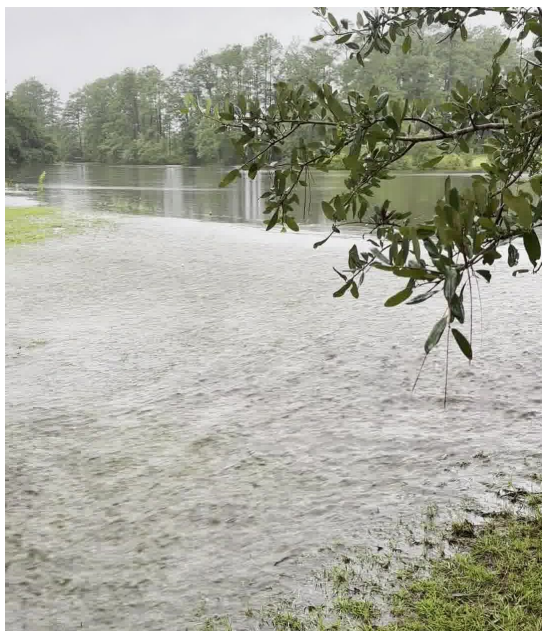
Flooding in Edisto Beach on August 6

McGrady's Pond in Colleton County overflows its banks after Debby's rain.

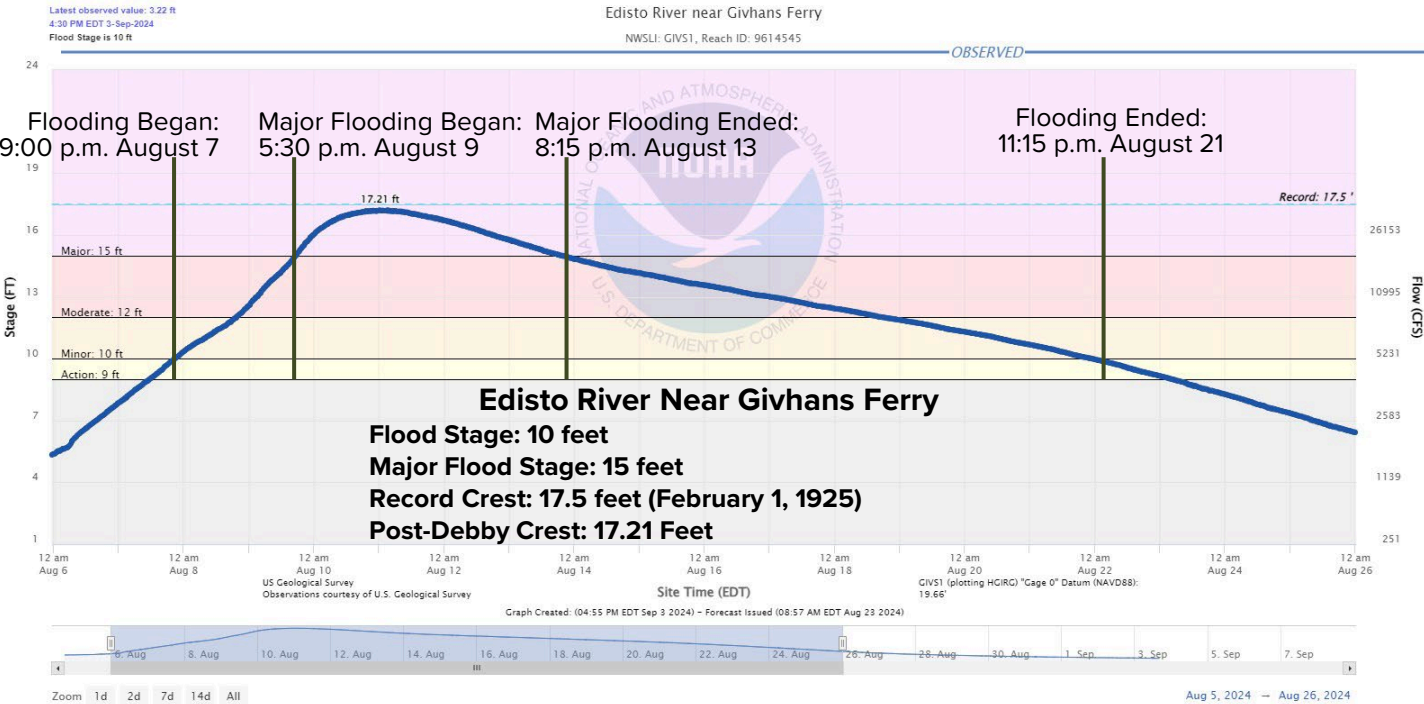
The Edisto River near Givhans Ferry crested at just below its record crest.

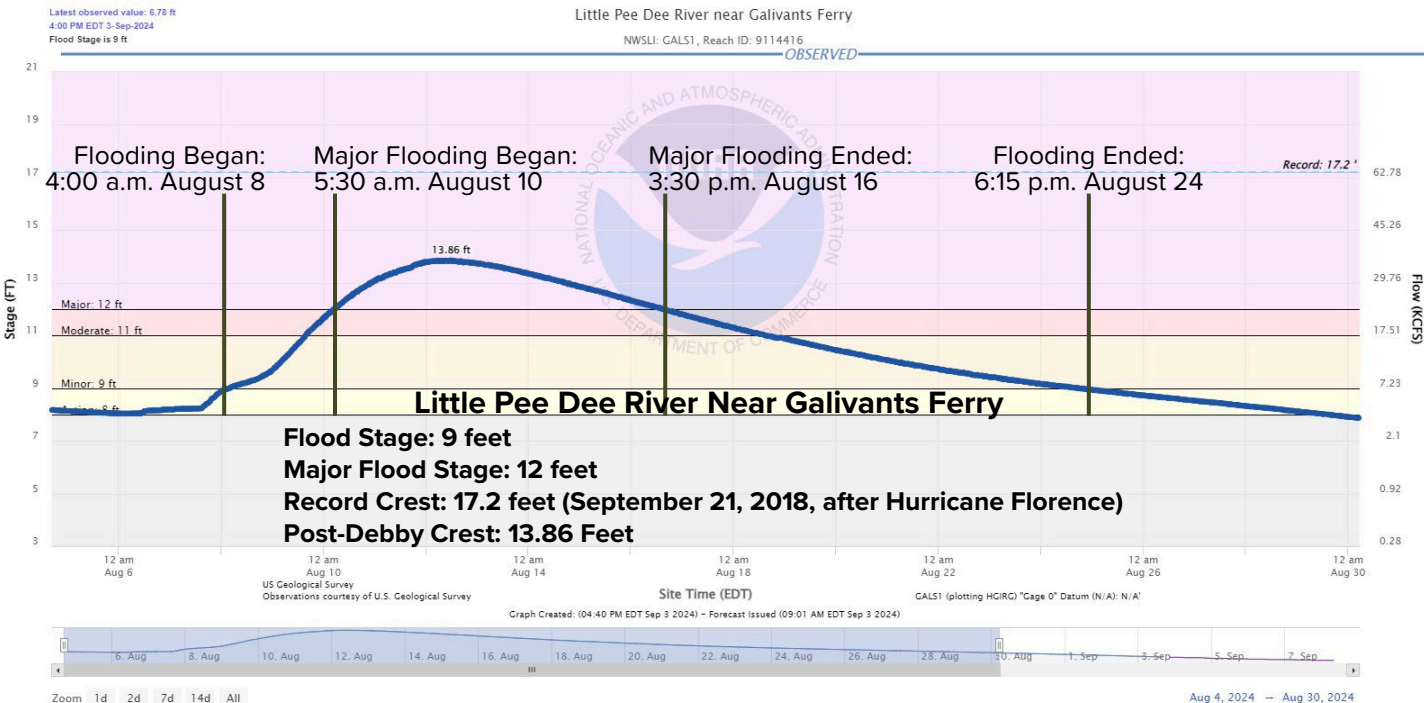
The Little Pee Dee River, which had shrunk to a trickle in July 2024 after months of drought, was above major flood stage for days in the wake of Debby.

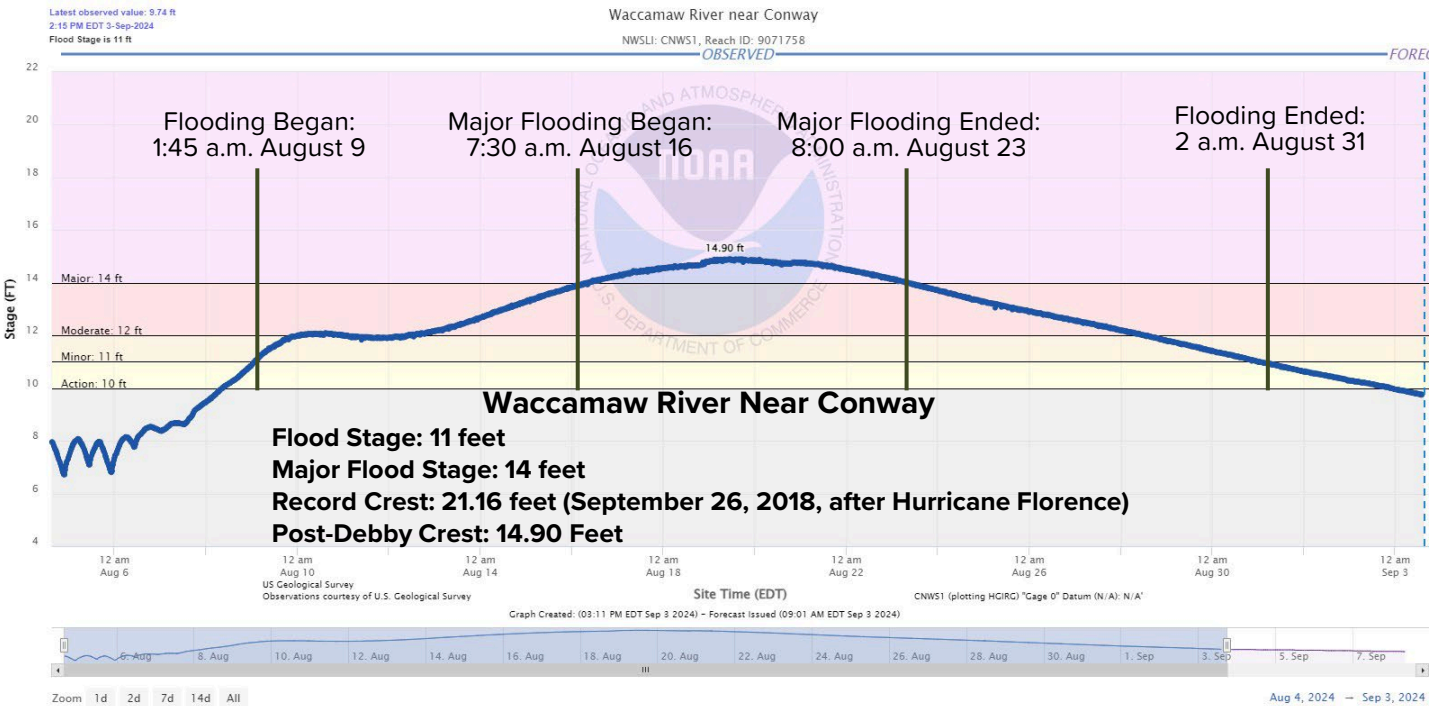
Flooding began along the Waccamaw River near Conway on August 9 and remained in flood until the early morning hours of August 31. The river was above major flood stage for about seven full days, and the flooding had significant impacts on area residents.

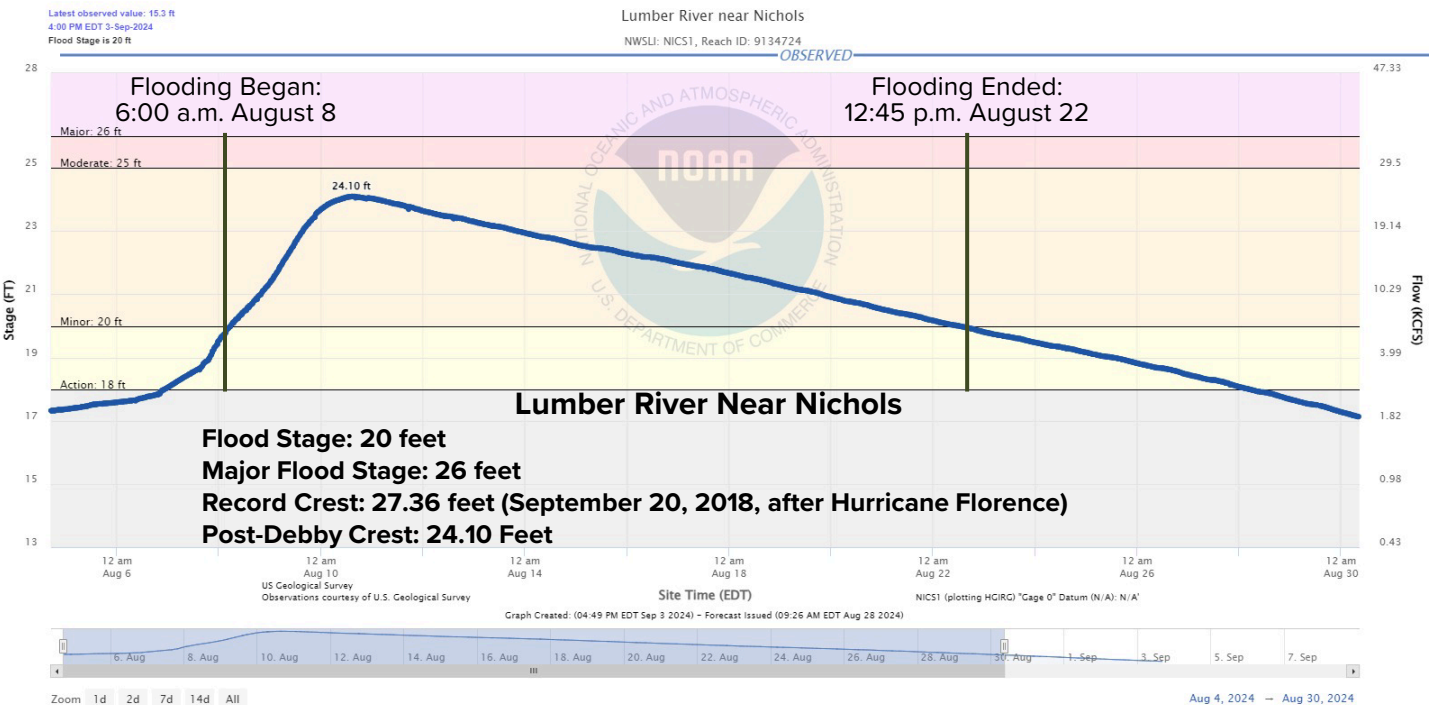
Flooding along the Lumber River in the Nichols area was not as bad as initially feared, as rainfall was not as extreme as forecast in the river's watershed in North Carolina. However, the crest after Debby was the third highest on record, and widespread flooding occurred in the Town of Nichols for the sixth time in the last ten years.

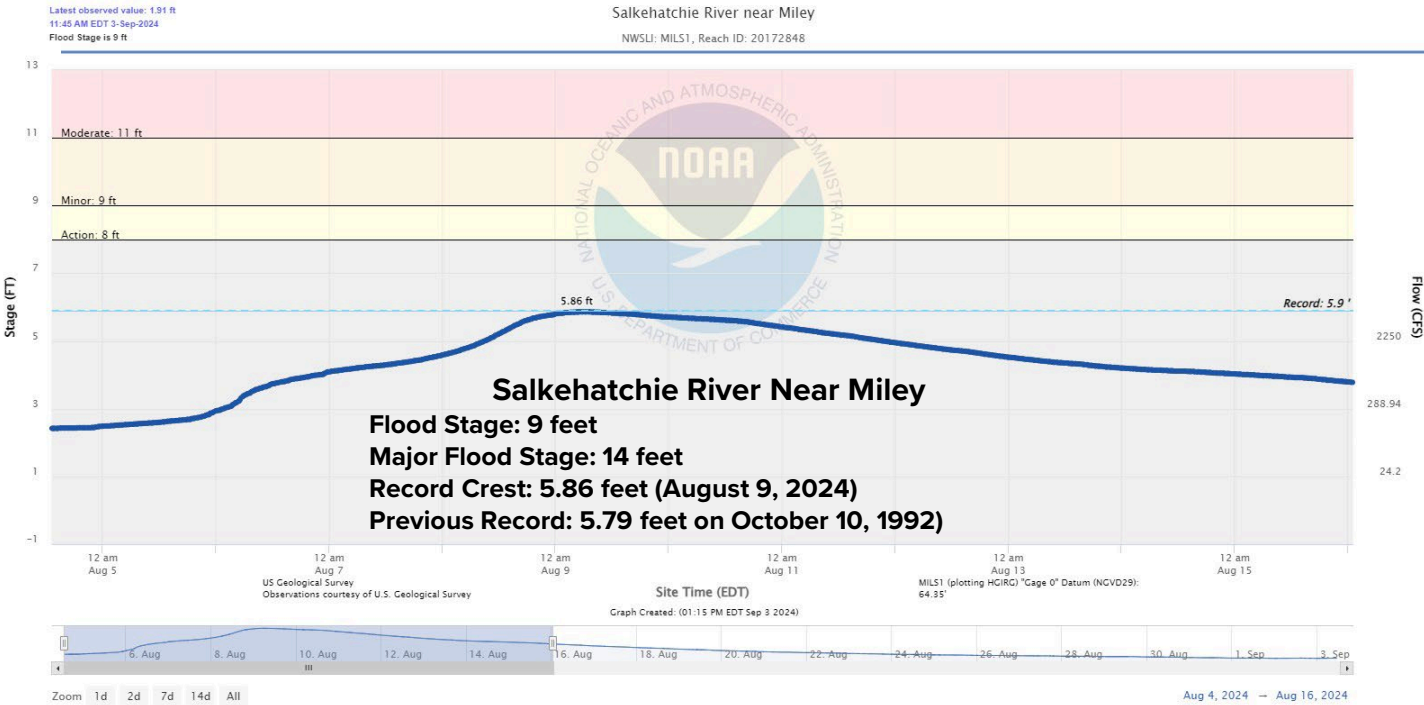
The Salkehatchie River saw a record crest at the gauge near Miley, but this river has not reached its 9-foot flood stage during its entire period of record dating back to 1985.

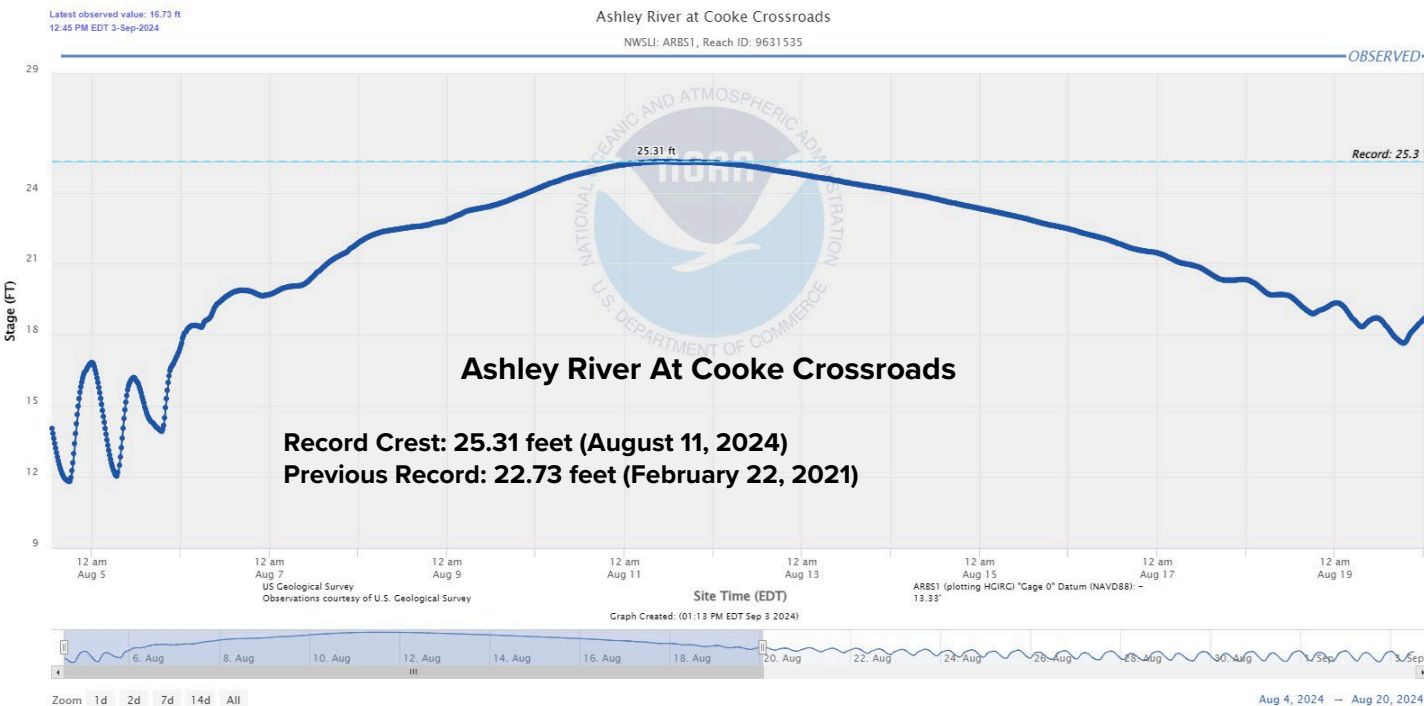
The Ashley River gauges at Cooke Crossroads has no defined flood stages. Observations began at this gauge on September 30, 1994.

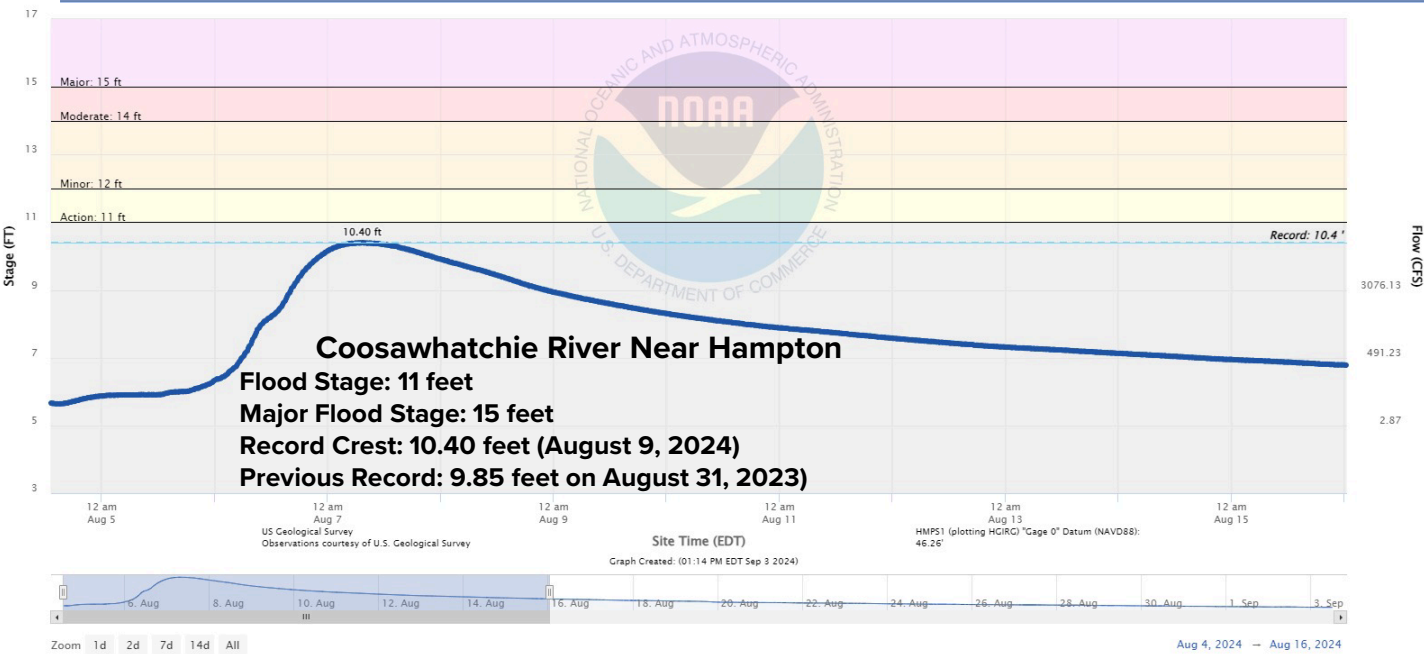
Coosawhatchie River near Hampton
NWSLI: HMP51, Reach ID: 20152151

The Coosawhatchie River saw a record crest at the gauge near Hampton, but this river has not reached its 11-foot flood stage during its entire period of record dating back to 1990.

Latest observed value: 5.38 ft
12:15 PM EDT 3-Sep-2024
Flood Stage is 12 ft

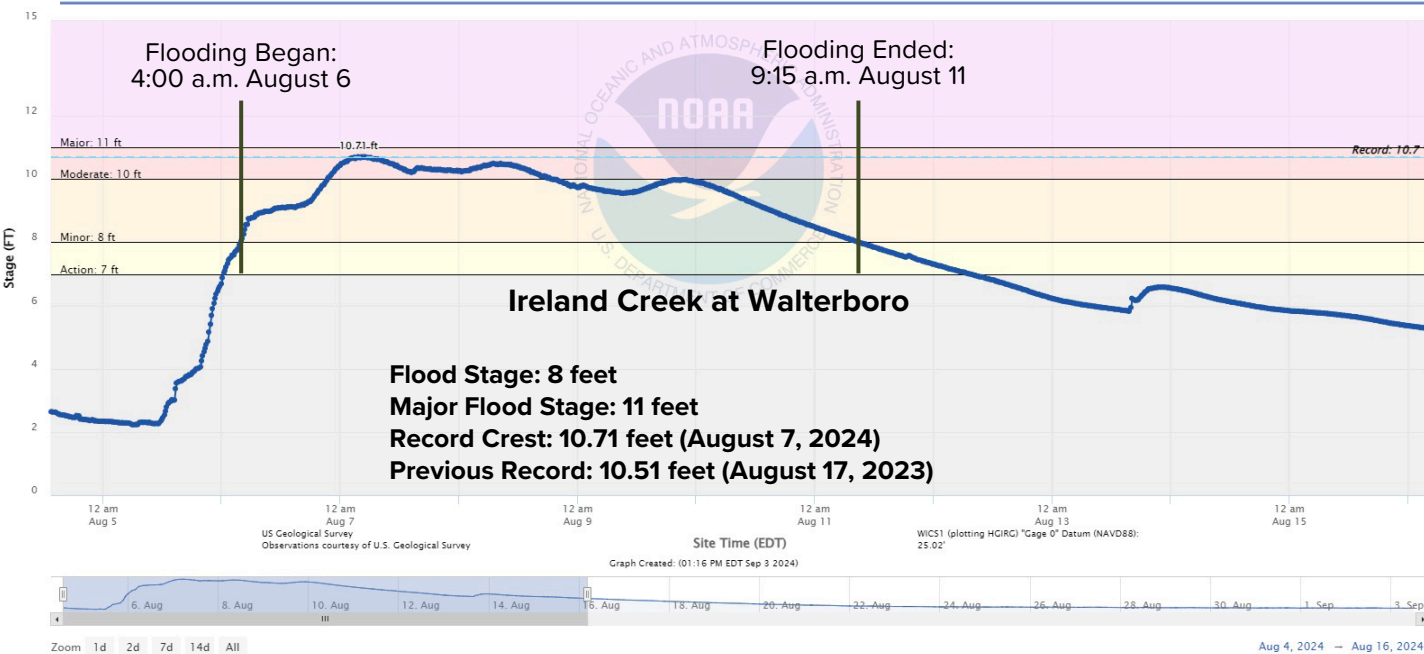
Ireland Creek at Walterboro
NWSLI: WICS1, Reach ID:

Ireland Creek reached a record crest at the Walterboro gauge after Debby. It was above flood stage for about five days, but was just short of the threshold for major flooding at this location.

Latest observed value: 2.56 ft
12:30 PM EDT 3-Sep-2024
Flood Stage is 8 ft

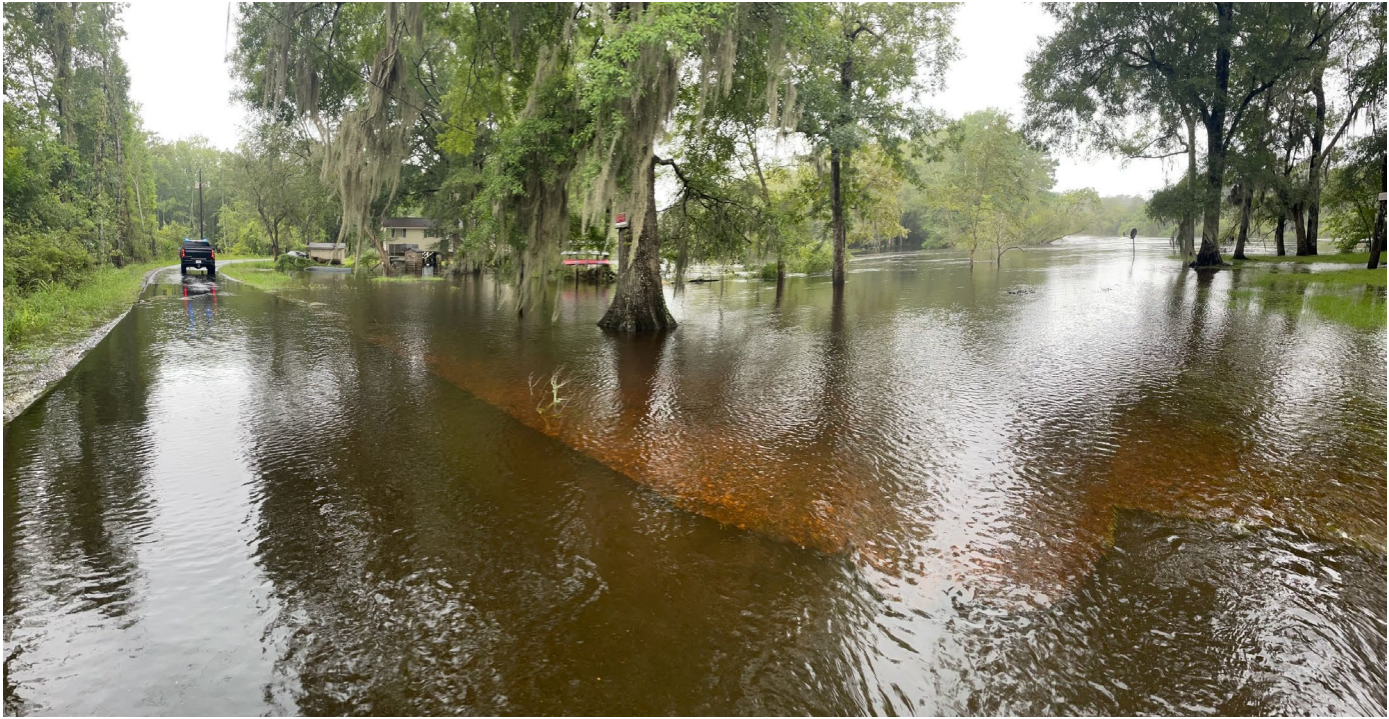
This photo of the Gator Walk Road area of Dorchester County from the morning of August 8 shows the extent of flooding at the time along this part of the Edisto River.

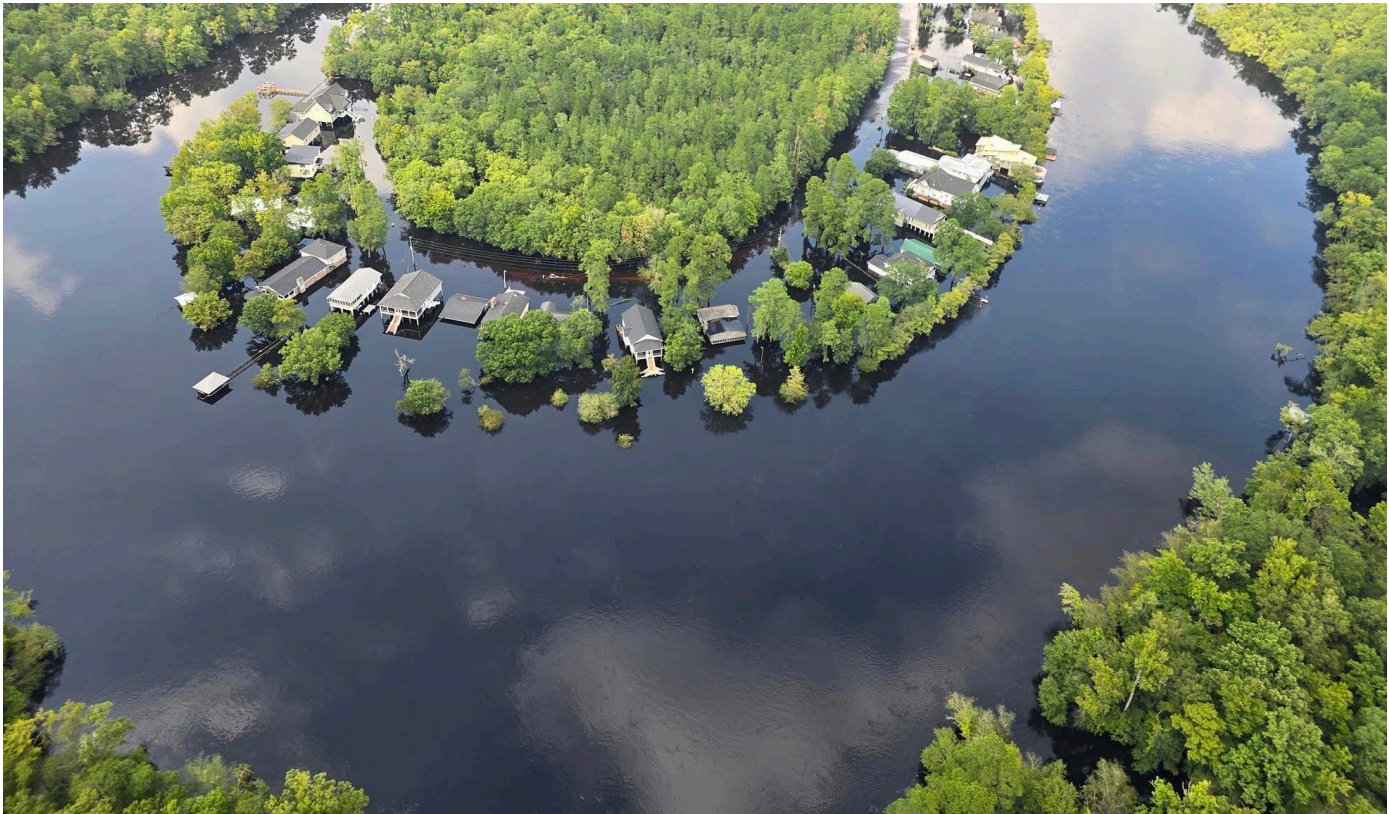
This photo of the Little Pee Dee River shows flooded homes in Marion County.

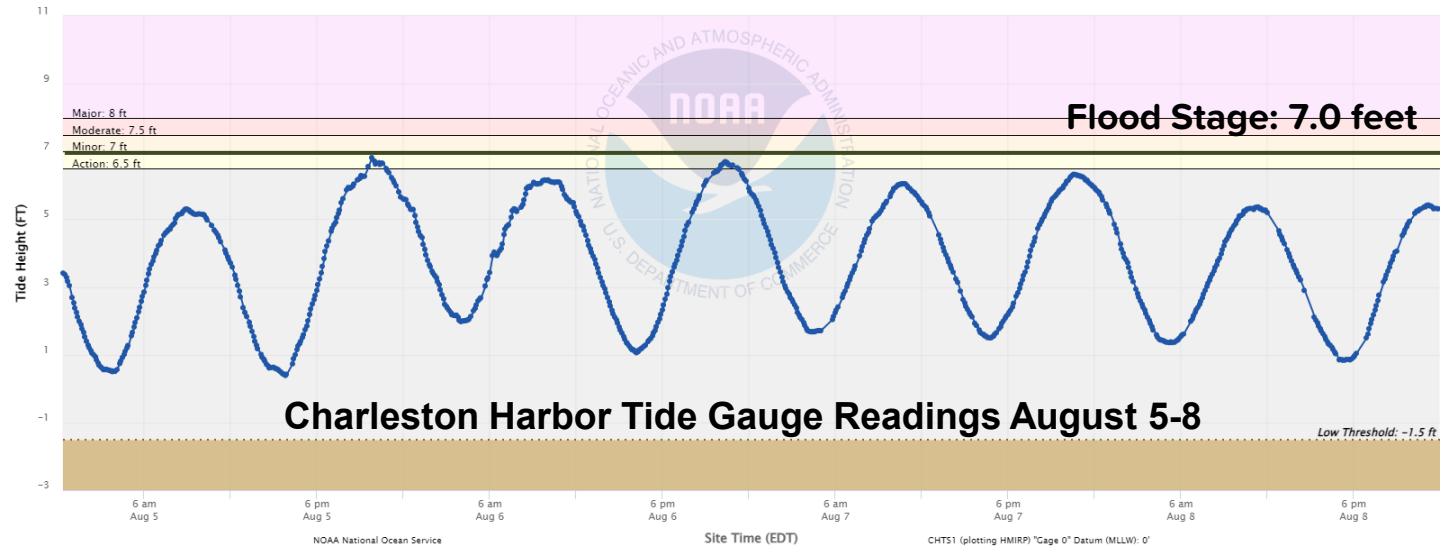
Charleston Harbor Tide Gauge (IN MLLW)

Latest observed value: 5.92 ft
2:42 PM EDT 14-Aug-2024
Flood Stage is 7 ft

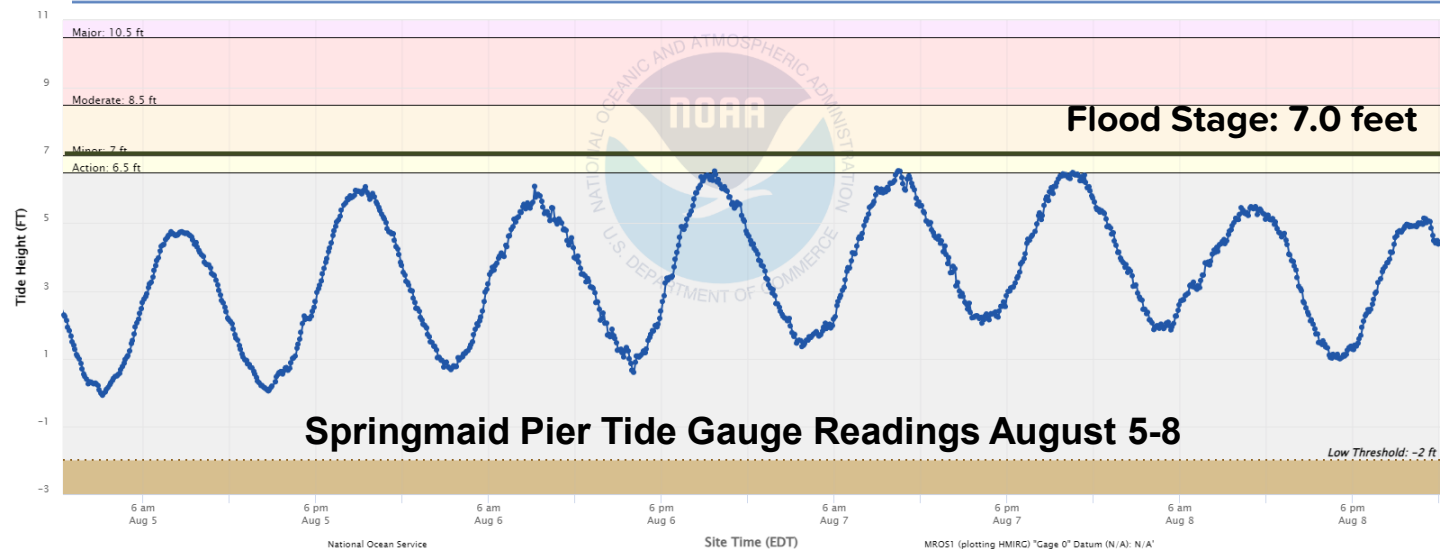
Atlantic Coast at Myrtle Beach Springmaid Pier (IN MLLW)

Latest observed value: 5.77 ft
2:48 PM EDT 14-Aug-2024
Flood Stage is 7 ft

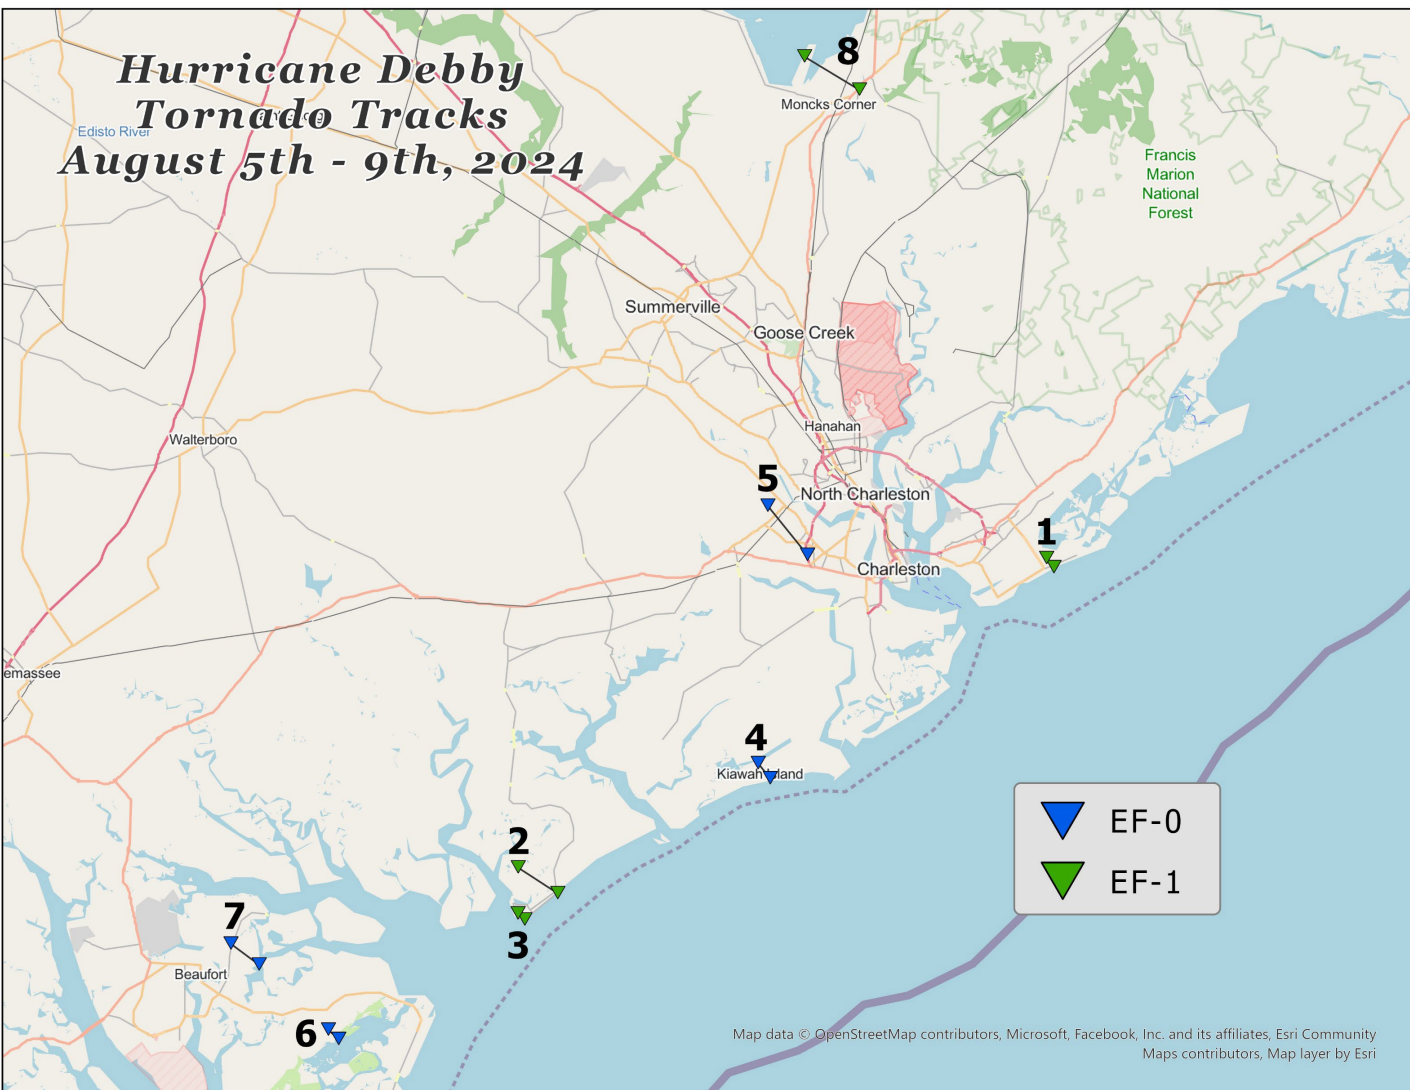
1. Isle of Palms, rated EF-1
2. Edisto Beach (North), rated EF-1
3. Edisto Beach (South), rated EF-1
4. Kiawah Island, rated EF-0
5. Charleston West Ashley, rated EF-0
6. St. Helena Island, rated EF-0
7. Ladys Island, rated EF-0
8. Moncks Corner, rated EF-1

Tornado tracks are approximate. Tornadoes rarely follow straight paths; they usually move in an arc and often rapidly shift to the left or right.

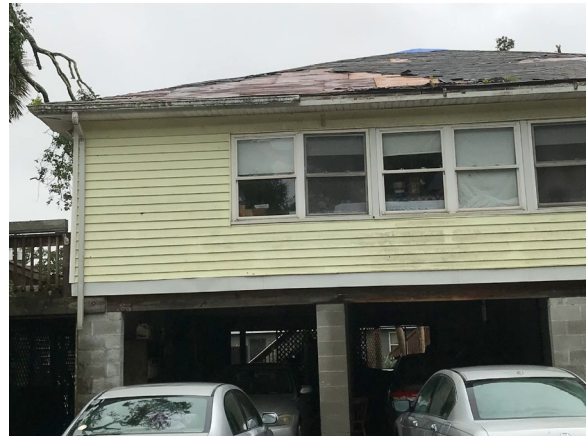
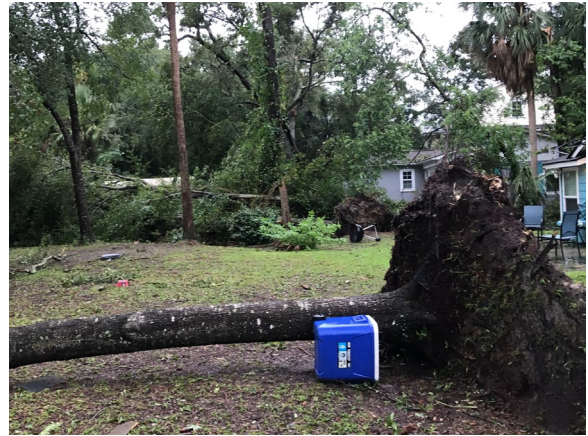
Tornado 1: Isle of Palms, Charleston County

This tornado began as a waterspout over the Atlantic that came ashore near 25th Avenue. It tracked along 25th Avenue and northwestward across Waterway Boulevard before lifting over the Intracoastal Waterway. It caused considerable tree damage along its path, with many trees uprooted or snapped. There was also minor structural damage to several homes such as stripped shingles and stripped siding, along with the front door pulled off one home.

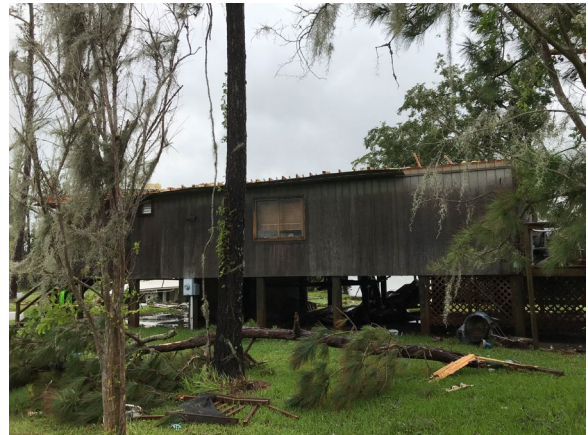
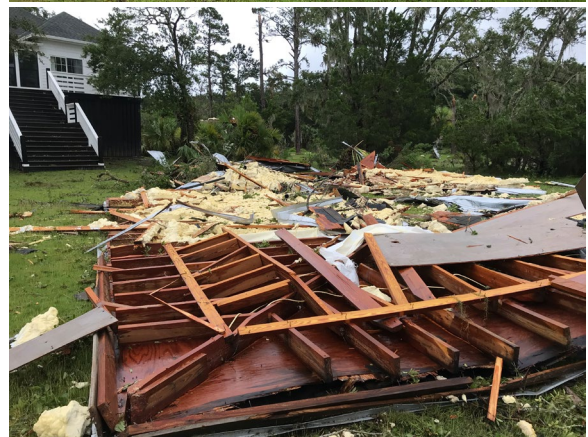
Tornado 2: Edisto Beach Area, Colleton and Charleston Counties

This tornado was a waterspout over the Atlantic Ocean that moved ashore on Edisto Island near Coral Street. It moved northwestward across Palmetto Boulevard and Jungle Road, then Palmetto Road, Palmetto Pointe Lane and Cocktail Lane. The worst damage was to homes and trees along Fishing Creek Drive.

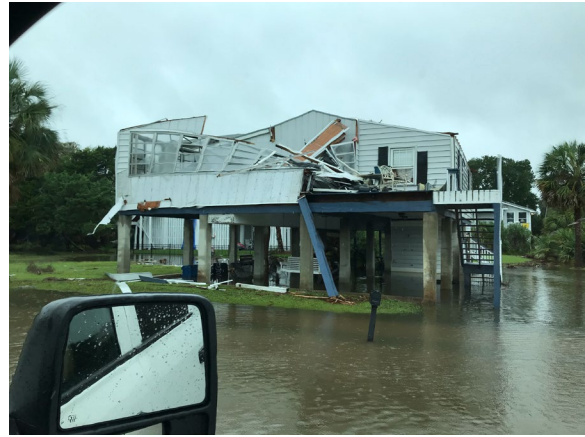
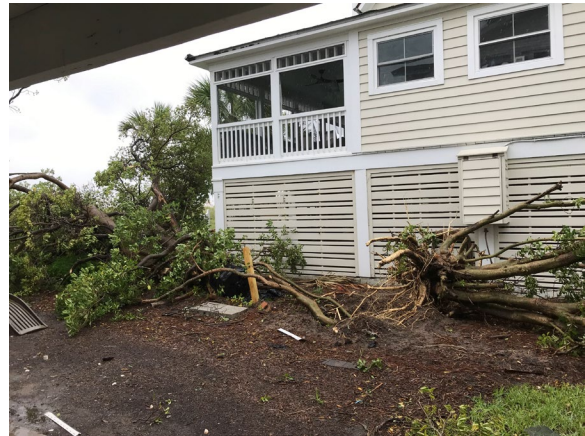
Tornado 3: Second Edisto Beach Tornado, Colleton County

This tornado began as a waterspout that came ashore near the intersection of Point Street and Laroche Street. It moved across Palmetto Boulevard, Myrtle Street, Lee Street, Neptune Street, and the southwest part of the Plantation Course at Edisto. The tornado caused damage to numerous trees and minor structural damage, including the demolition of a screened porch along Palmetto Boulevard.

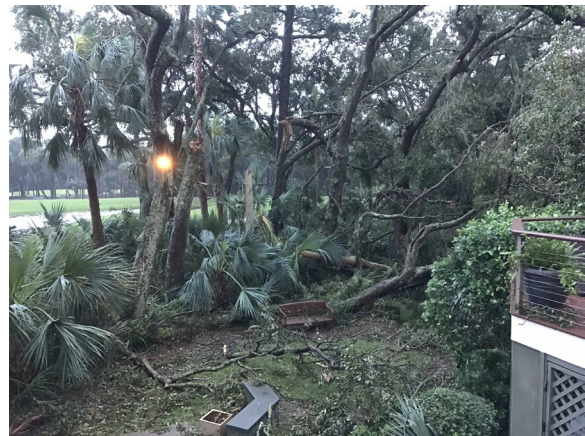
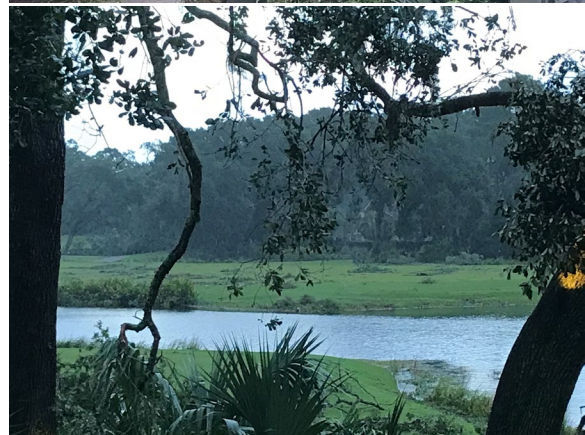
Tornado 4: Kiawah Island, Charleston County

This tornado began as a waterspout over the Atlantic Ocean and came ashore along Surfsong Road, then moved northwestward over Glen Abbey, Doral Open, Governors Drive before ending over marshland near Rhett's Bluff Road. The tornado caused no structural damage but caused some tree damage and left debris over the golf course along its path.

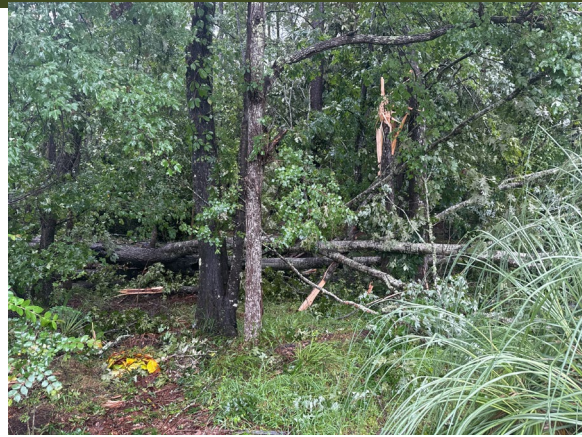
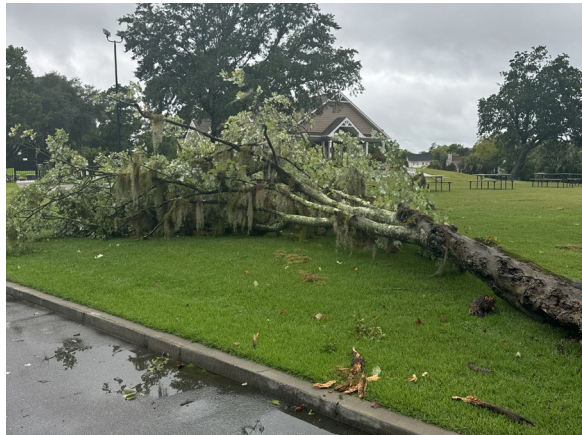
Tornado 5: Charleston West Ashley, Charleston County

This tornado began along I-526 near Citadel Mall and tracked northwestward over Bon Secours Hospital, Glenn McConnell Parkway, Mariners Ferry, and across the Hickory Hall Plantation neighborhood, ending near Muirfield Parkway. The tornado did not cause any structural damage, but caused several instances of tree damage, including some downed or snapped trees.

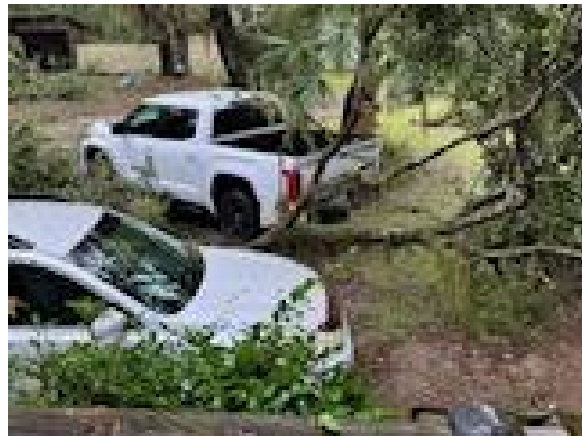
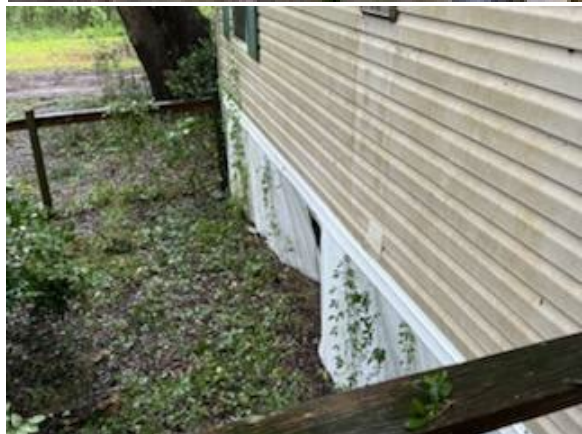
Tornado 6: St. Helena Island, Beaufort County

This tornado began as a waterspout over Harbor River and crossed marshland and came ashore near 1st Coleman Road. It tracked along that road and lifted as it reached Seaside Road. The tornado primarily caused tree damage along its path, but it also broke a flagpole and damaged the metal skirting of a mobile home.

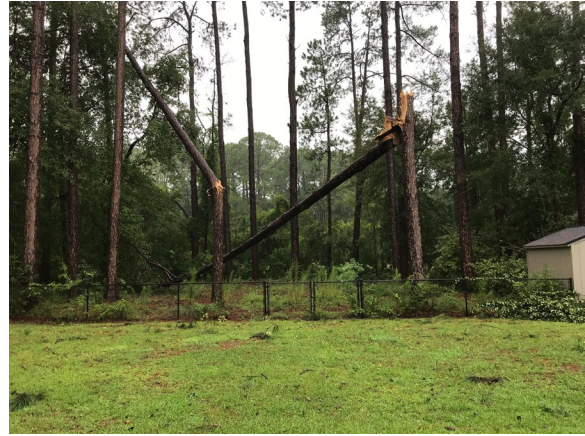
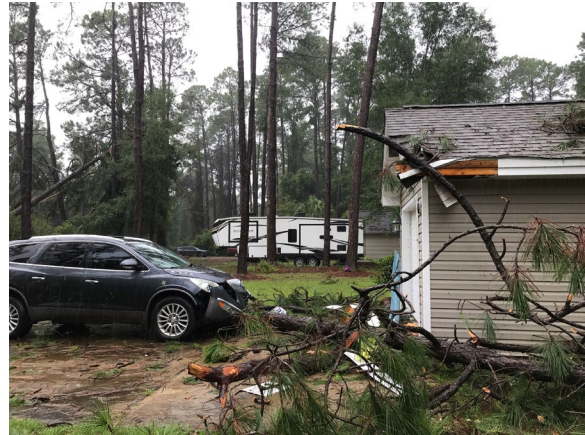
Tornado 7: Lady's Island, Beaufort County

This tornado began in marshland adjacent to Point Creek and moved northwestward across Holly Hall Road, Sheppard Road and S. C. Highway 802 (Sam's Point Road), then ended along Wade Hampton Drive. The tornado snapped several trees and caused other tree damage; no structural damage was caused directly by the tornado's wind, but some of the tree debris landed on homes and vehicles and caused damage.
