Tropical Cyclone Debby

Open File Report

Storm History and Impacts Report

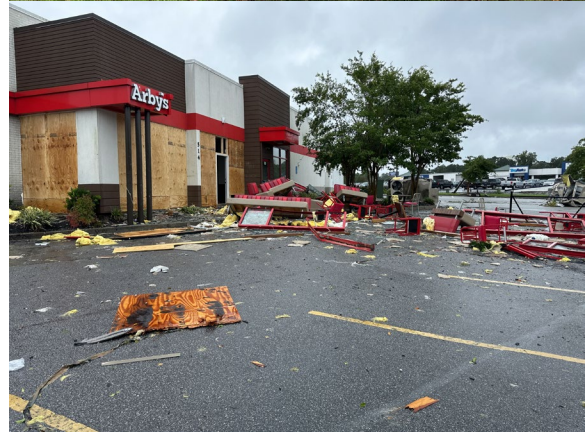
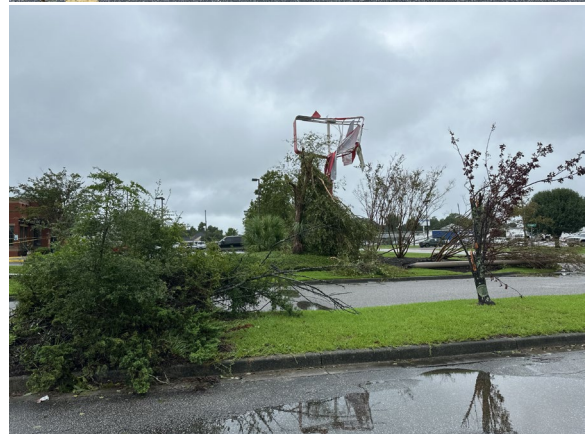
Tornado 8: Moncks Corner, Berkeley County

This tornado began along U. S. Highway 52 and moved northwestward through the north part of Monck's Corner, crossing over a part of Lake Marion before ending in Pinopolis. Several businesses and homes were damaged, with the worst damage at Arby's along McCormick Circle.

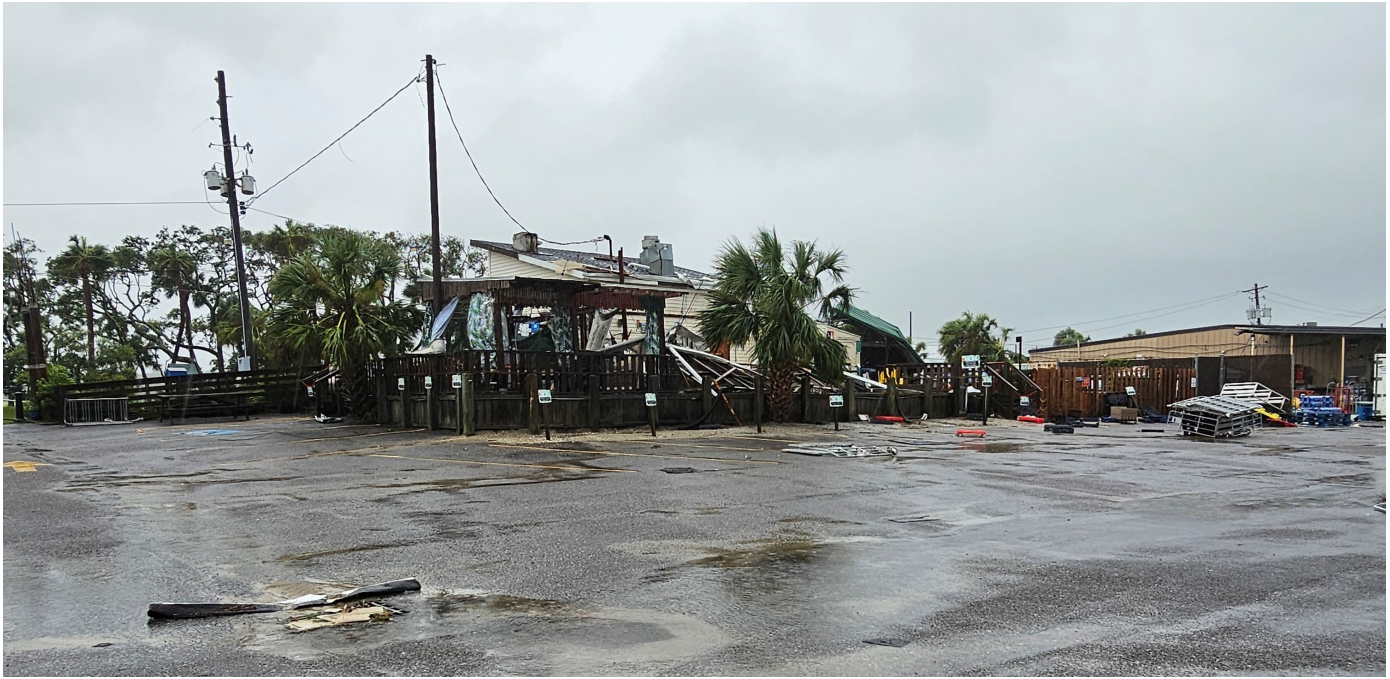
McConkey's Jungle Shack in Edisto Beach suffered major damage from the First Edisto Beach Debby Tornado. The restaurant was closed for many days after the tornado.

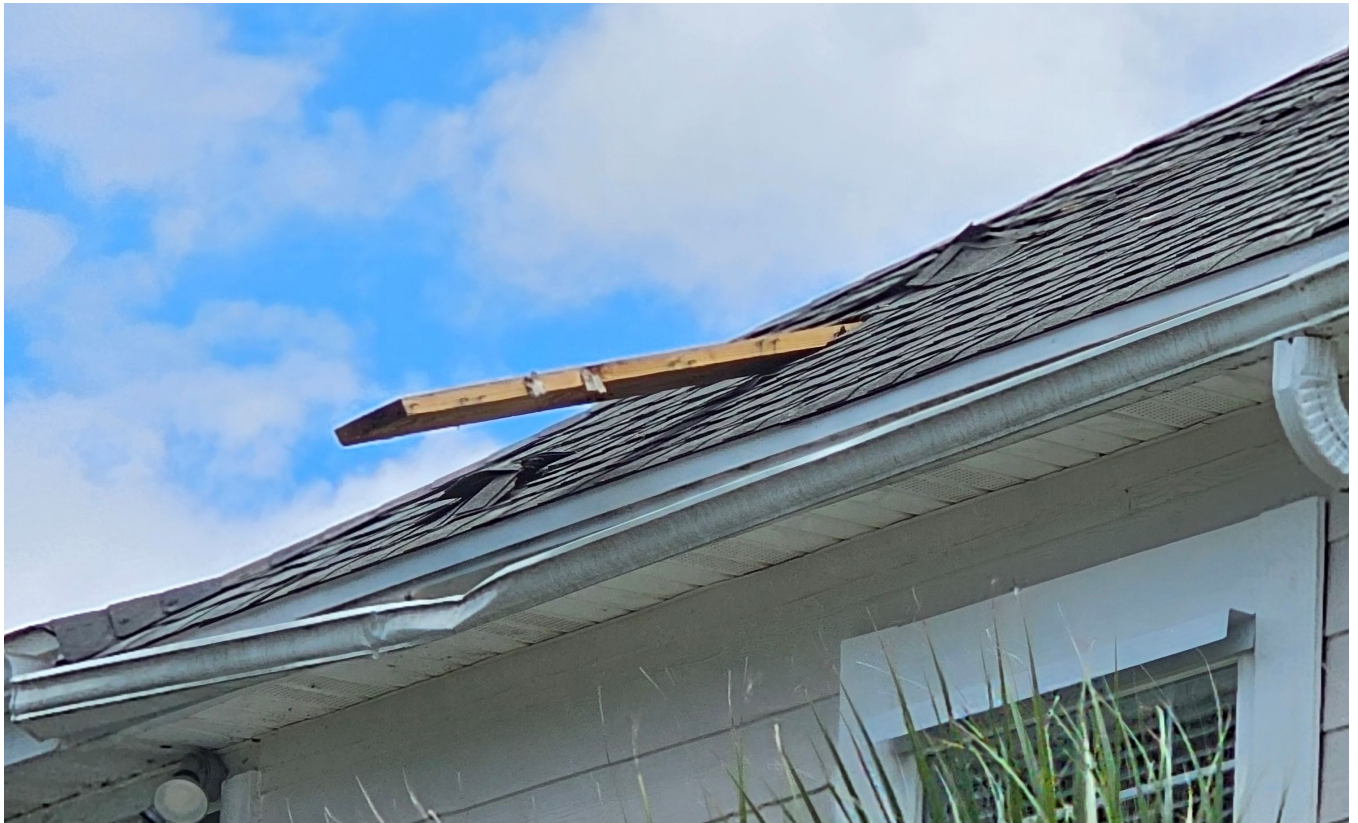
A home along Neptune Street in Edisto Beach had a board driven into its roof by the Second Edisto Beach Debby Tornado.
